**Flood Control Project Maintenance
Levee Inspections**

Fall 2018 Levee Maintenance Deficiency Summary Report

San Joaquin River Basin

Reclamation District No. 0017 Mossdale

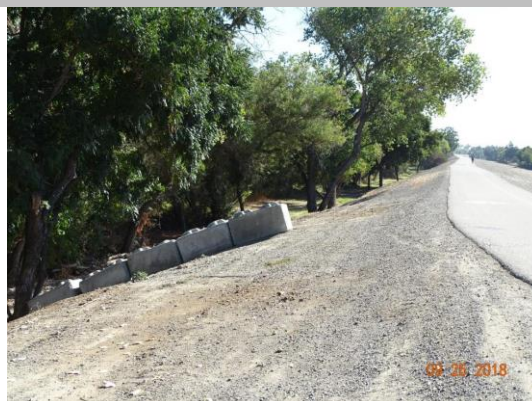
Photo 1 of 1 : FA_2018_RD0017_303_10_20180927_00017.jpg

Looking southeast at typical view of waterward slope. (Fall 2018)

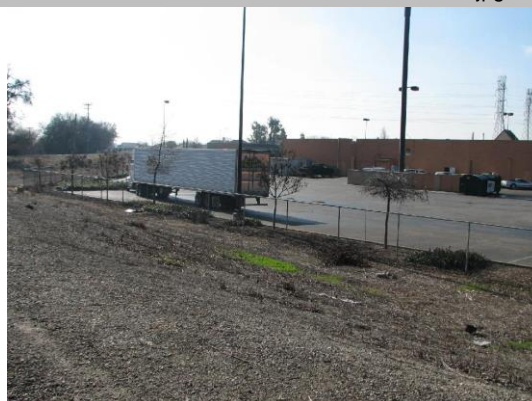
Photo 3 of 3 : UCIP_FA_2018_40603_38478.jpg

Comment Code						
Inspector Comment						
FS_ID:40603						
DS_ID:1						
EP_NO: 6623						
Repair Type: Non-Urgent						
Crossing Status: Found						
UCIP Comments: Marker missing on landward side. Need to contact owner to determine status of crossing. Need date of last inspection and confirmation that crossing is still in operable condition.						
FIELD_STRUCT_DESC: 5.563-inch welded steel natural gas pipeline through the levees, 4.5 feet below the crown, across the channels and overflow area. (5-inch gas line authorized under Permit No. 6623, 1969 - Laymac Corporation) [Additional Reference(s): DWR Levee Logs, 1981, 2003].						
FS Date: 2/3/2010

View of landward side.

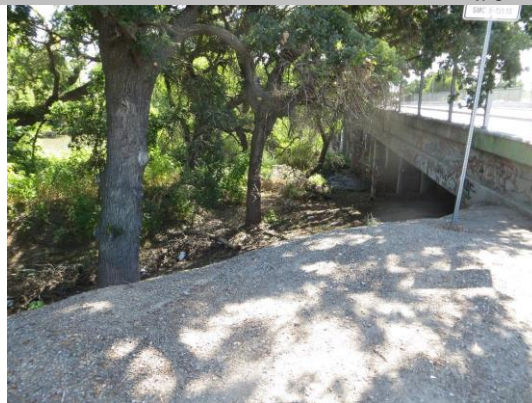
Photo 2 of 3 : UCIP_FA_2018_49990_74221.jpg

FS_ID:49990
DS_ID:72
EP_NO: 15185
Repair Type: Non-Urgent
Crossing Status: Indicator Found
UCIP Comments: 04/06/2018 Received supporting information from T. Marlow with KSN pertaining to line. PG&E has installed gas line distribution markers on both shoulder of the levee. Crossing is an active line. PG&E performs a leak survey at least twice a year according to Mr. R. Muok, Supervisor, Gas Pipeline Operations and Maintenance Stockton. Mr. Muok can be reached at 209-406-7926. Crossing has been downgraded from Urgent to Non-Urgent--pipe is inspected by owner. UCIP will need to coordinate with PG&E to obtain confirmation of inspections, obtain emergency contact information, and maintenance contact information. (DWR UCIP - O. Magana)
07/12/2016 No markers (no photos taken in 2016). Need to contact owner to determine status of crossing. If crossing is active, owner will need to coordinate with CVFPB to install markers to comply with Title 23. (DWR UCIP - omagana)5/19/2015 Need to install gasline markers. (DWR UCIP - omagana)

WS Slope. No gasline markers.

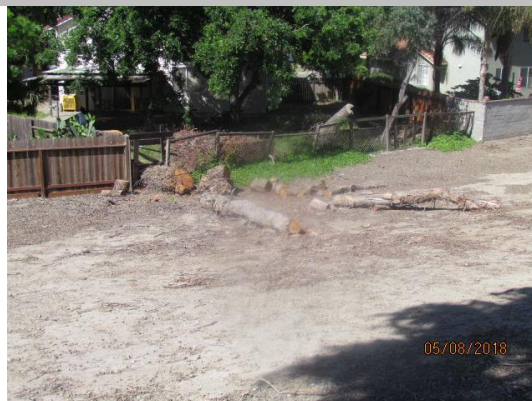
Photo 1 of 1 : FA_2018_RD0017_303_11_20180906_00001.jpg

Looking west at tree limbs on landward slope and toe. (Spring 2018)

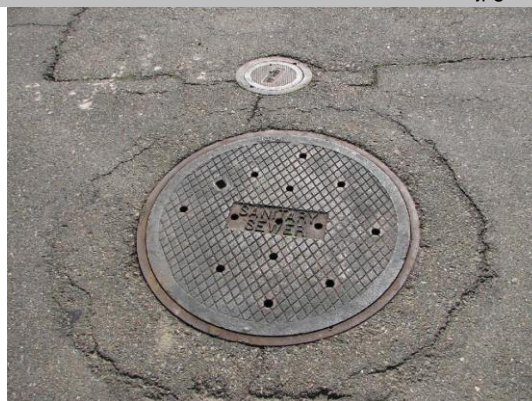
Photo 3 of 3 : UCIP_FA_2018_40604_38495.jpg

Comment Code						
Inspector Comment						
FS_ID:40604						
DS_ID:2						
EP_NO: 14992						
Repair Type: Non-Urgent						
Crossing Status: Indicator Found						
UCIP Comments: Need to contact owner to determine status of crossing. Also need date of last inspection.						
FIELD_STRUCT_DESC: [Weston Ranch - French Camp Slough Crossings] 1 of 3. 30-inch high-density polyethylene (HDPE) sewer force main (SFM) through the levee, 32 feet below levee crown. All pipes encased in concrete. (two 30-inch force mains (originally issued as 27-inch) and one 12-inch pipe authorized under Permit No. 14992, 1989 - City of Stockton and Richard Blewett) [Additional Reference(s): DWR Levee Logs, 1981, 2003]						
FS Date: 2/3/2010

Manhole found on landward side.

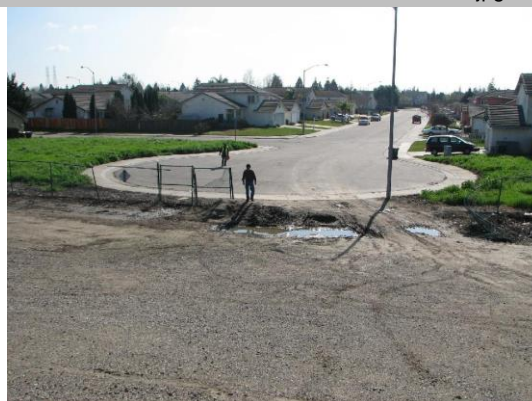
Photo 2 of 3 : UCIP_FA_2018_52614_38503.jpg

Comment Code						
Inspector Comment						
FS_ID:52614						
DS_ID:159						
EP_NO: 14992						
Repair Type: Non-Urgent						
Crossing Status: Indicator Found						
UCIP Comments: Need to contact owner to determine status of crossing. Also need date of last inspection.						
FIELD_STRUCT_DESC: [Weston Ranch - French Camp Slough Crossings] 2 of 3. 30-inch high-density polyethylene (HDPE) sewer force main (SFM) through the levee, 32 feet below levee crown. All pipes encased in concrete. (two 30-inch force mains (originally issued as 27-inch) and one 12-inch pipe authorized under Permit No. 14992, 1989 - City of Stockton and Richard Blewett) [Additional Reference(s): DWR Levee Logs, 1981, 2003]						
FS Date: 2/3/2010

View of landward toe--established neighborhood.

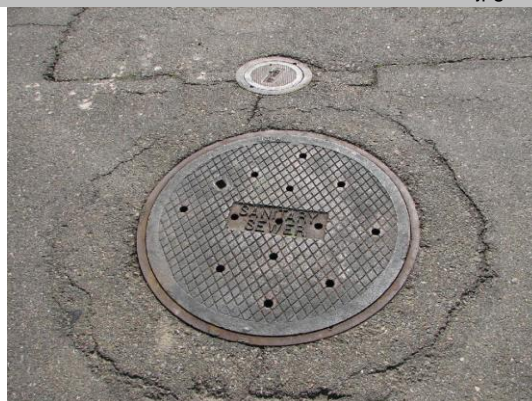
Photo 3 of 3 : UCIP_FA_2018_40606_71940.jpg

Comment Code						
Inspector Comment						
FS_ID:40606						
DS_ID:158						
EP_NO: 14992						
Repair Type: Non-Urgent						
Crossing Status: Indicator Found						
UCIP Comments: Need to contact owner to determine status of crossing. Also need date of last inspection.						
FIELD_STRUCT_DESC: [Weston Ranch - French Camp Slough Crossings] 3 of 3. 12-inch high-density polyethylene (HDPE) sewer force main (SFM) through the levee, 32 feet below levee crown. All pipes encased in concrete. (two 30-inch force mains (originally issued as 27-inch) and one 12-inch pipe authorized under Permit No. 14992, 1989 - City of Stockton and Richard Blewett) [Additional Reference(s): DWR Levee Logs, 1981, 2003]						
FS Date: 2/3/2010

Manhole visible on landward side.

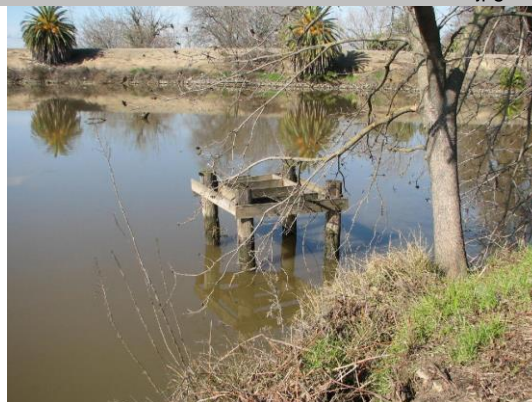
Photo 2 of 3 : UCIP_FA_2018_40628_38515.jpg

Comment Code						
Inspector Comment						
FS_ID:40628						
DS_ID:75						
EP_NO: 15093						
Repair Type: Non-Urgent						
Crossing Status: Found						
UCIP Comments: Only appurtenances remaining at this location--4 pillings located on waterward side. According to records the pillings were to be removed under a completion maintenace contract. Need to coordinate with owner.						
FIELD_STRUCT_DESC: 14-inch-diameter pipeline through levee at unknown depth. Per inspector's notes "this crossing is abandoned almost all materials removed including pipes, conduit, and pump house. The only items left are 4 pilings which are to be removed under a completion maintenance contract. Approximately 200 feet of reinforced concrete pipe lateral removed in R/W south of crossing".						
FS Date: 2/3/2010

View of waterward side--pillings inside channel.

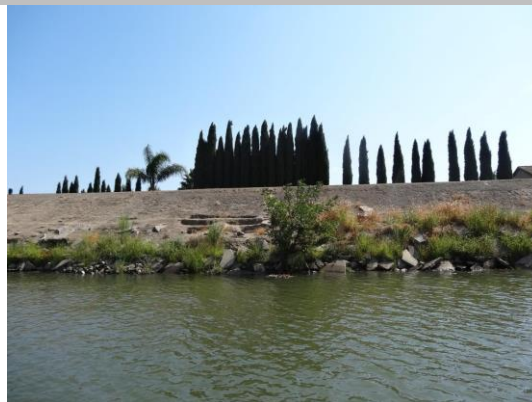
Photo 1 of 2 : FA_2018_RD0017_304_2_20180906_00003.jpg

Front view of the erosion.

LM Start	0.91	Rating **	C	Issue No.	3
LM End	0.91	Issue Type +	Ma	Location *	WS
Category	Supplemental			GPS Latitude/Longitude	
				Start	End
Item	DWR Erosion Survey			37.904310 °	37.904310 °
				-121.323386 °	-121.323386 °
DWR ID	RD0017U02RM44.14				
Comment Code					
Inspector Comment					
09/13/2017: The erosion is located upstream of a big tree. [2017 Site ID:RD0017U02RM44.14] District repaired site.

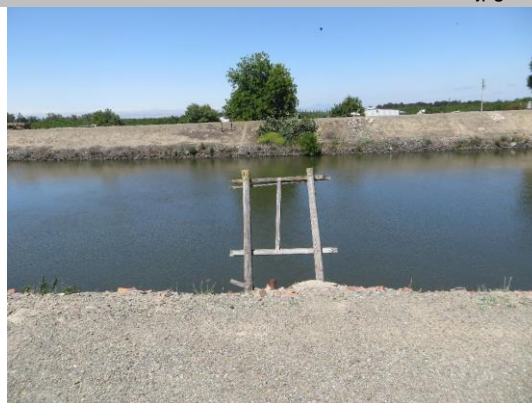
Photo 1 of 2 : UCIP_FA_2018_45449_74105.jpg

LM Start	1.18	Rating **	M	Issue No.	89	
LM End	1.18	Issue Type +	En	Location *		
Category	Supplemental			GPS Latitude/Longitude		
				Start	End	
Item	DWR UCIP Field Study			37.901012 °	37.901012 °	
				-121.325497 °	-121.325497 °	
DWR ID	9					
Comment Code						
Inspector Comment						
FS_ID:45449						
DS_ID:9						
EP_NO: N/A						
Repair Type: Non-Urgent						
Crossing Status: Indicator Found						
UCIP Comments: Appears abandoned. Should contact owner to determine status as signs have been removed from supports and should be replaced if still in service.						
FIELD_STRUCT_DESC: Underground telephone cable through levee, 2 feet below crown. Warning signs on waterside (WS) slope. [Additional Reference(s): DWR Levee Logs, 1981, 2003]						
FS Date: 5/19/2015

Sign on WS slope.

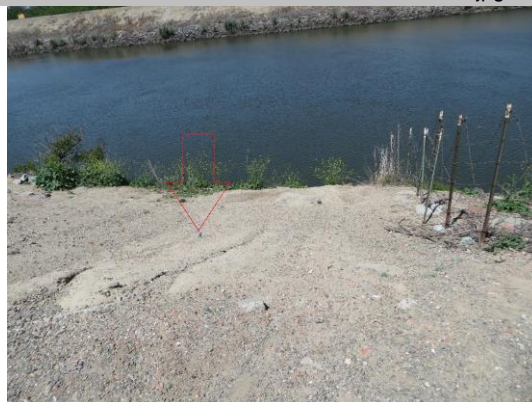
Photo 1 of 2 : UCIP_FA_2018_49637_74109.jpg

View of WS slope with electrical conduit.

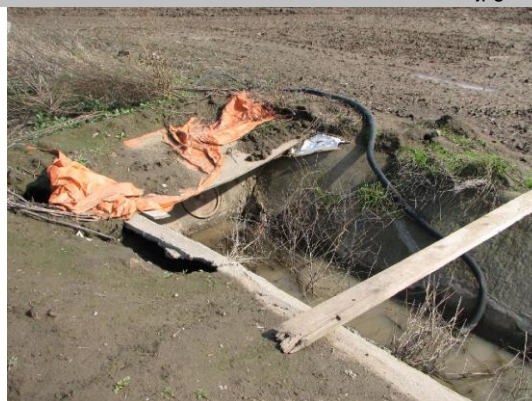
Photo 3 of 3 : UCIP_FA_2018_40640_71983.jpg

Concrete irrigation canal located at landward toe just upstream of crossing.

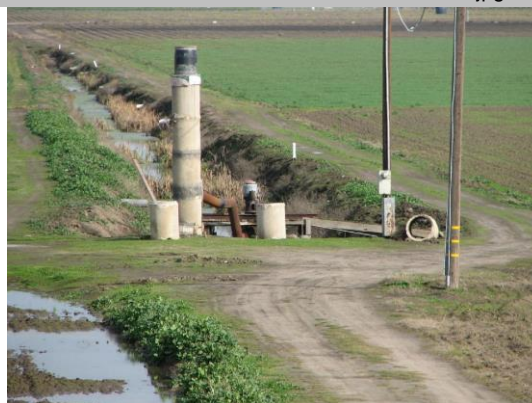
Photo 3 of 3 : UCIP_FA_2018_40642_38746.jpg

Unidentified appurtenances located on landward side-unable to confirm if pipe crosses levee.

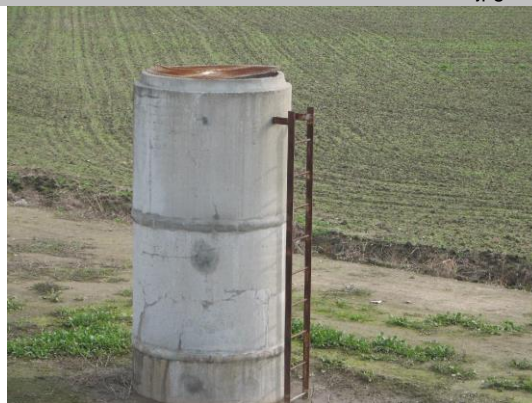
Photo 2 of 3 : UCIP_FA_2018_40645_72001.jpg

Standpipe located on landward toe.

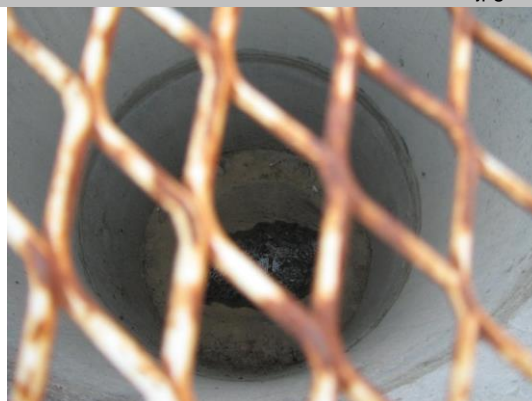
Photo 3 of 3 : UCIP_FA_2018_40646_72008.jpg

Inside view of standpipe located on landward side.

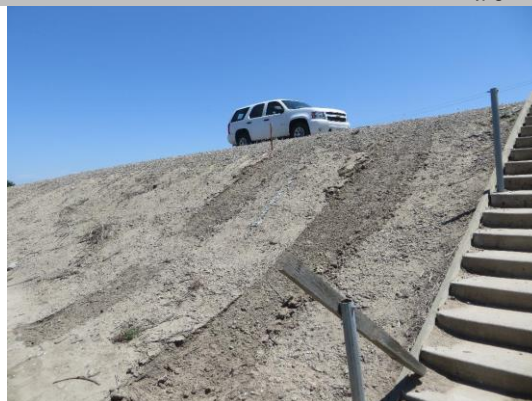
Photo 2 of 3 : UCIP_FA_2018_46009_74441.jpg

(2015) View of waterward slope--pipe removed.

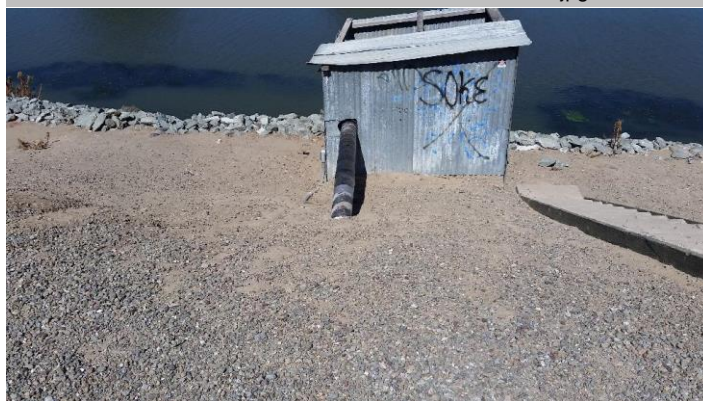
Photo 1 of 3 : UCIP_FA_2018_53328_75745.jpg

View of WS--slope cleared of vegetation.

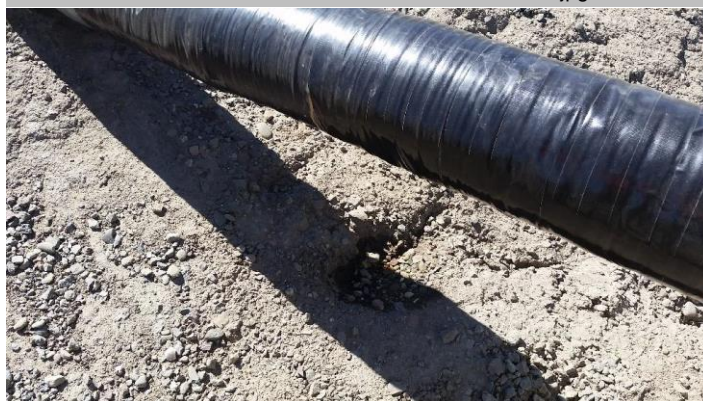
Photo 2 of 3 : UCIP_FA_2018_53328_75742.jpg

WS view--moisture observed on ground below wrapped pipe section, photo 1 of 2.

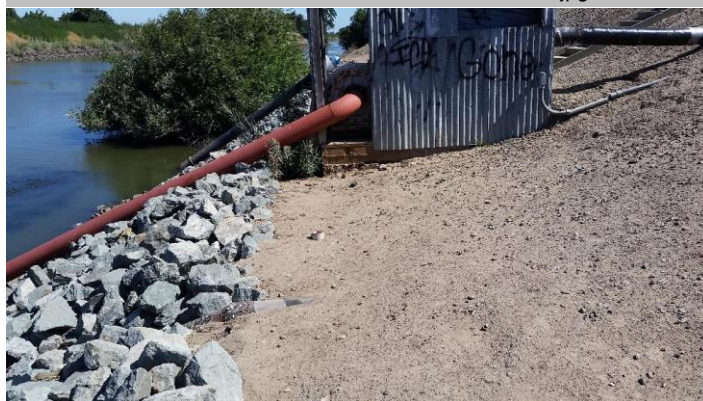
Photo 3 of 3 : UCIP_FA_2018_53329_75734.jpg

WS-pipe daylight just above rip rap near red pipe.

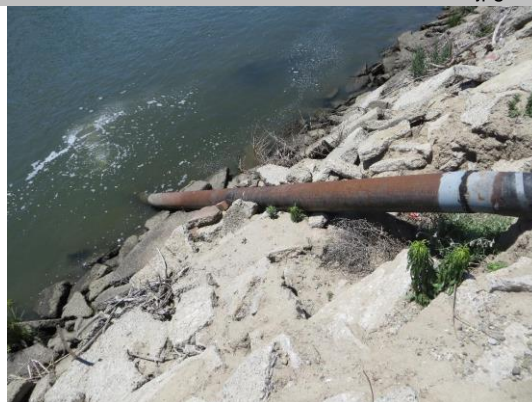
Photo 2 of 3 : UCIP_FA_2018_46005_74458.jpg

(2015) Pipe section replaced.

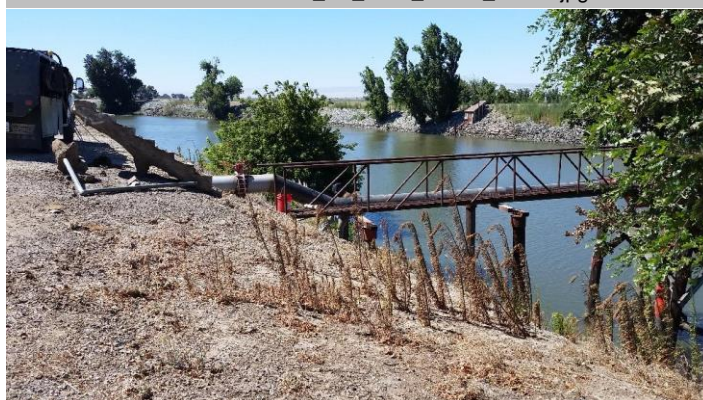
Photo 2 of 3 : UCIP_FA_2018_50004_75871.jpg

View of WS--coated pipe, walkway, and removal of concrete stairway. Construction in progress.

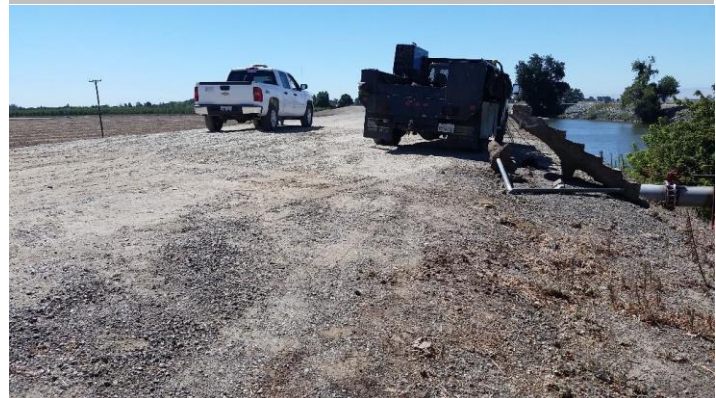
Photo 3 of 3 : UCIP_FA_2018_50004_75872.jpg

View of levee crown--construction on LS and WS in progress.

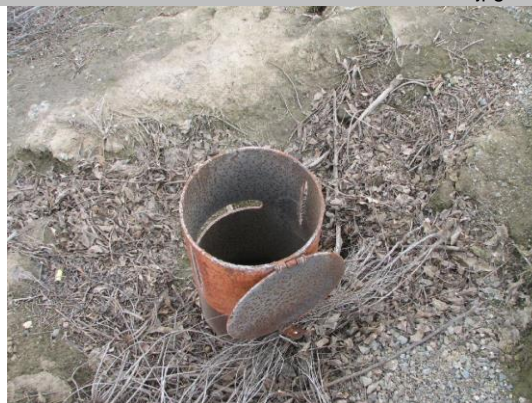
Photo 3 of 3 : UCIP_FA_2018_40659_72114.jpg

Siphon breaker located on landward slope.

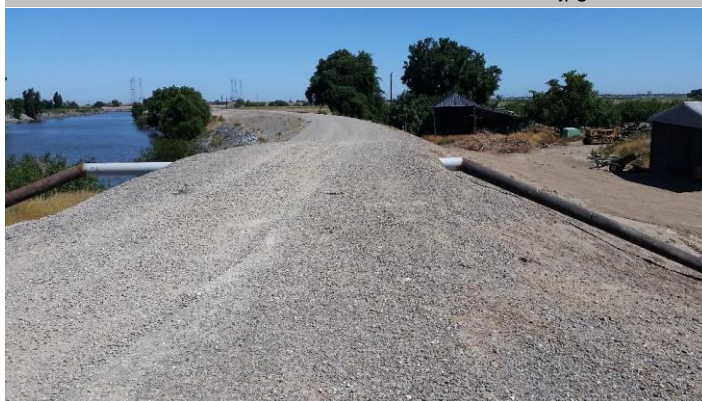
Photo 3 of 3 : UCIP_FA_2018_50005_75865.jpg

View of levee crown--levee section where pipe crosses is raised.

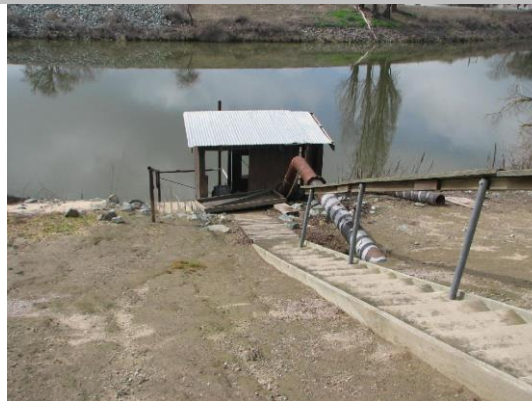
Photo 2 of 3 : UCIP_FA_2018_40662_72128.jpg

View of waterward side--pump house, walkway, pipe, and abandoned pipe section.

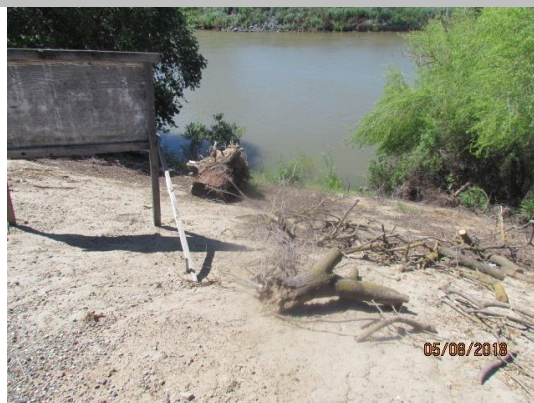
Photo 1 of 1 : FA_2018_RD0017_304_86_20180906_00016.jpg

Looking southwest at tree stump and tree limbs on waterward slope.
(Spring 2018)

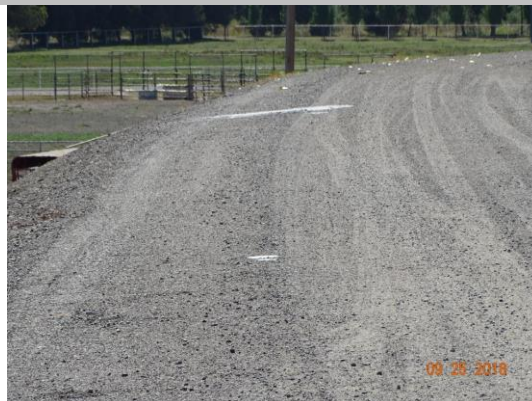
Photo 2 of 2 : FA_2018_RD0017_304_82_20180927_00202.jpg

Looking southeast at typical view of grouted rodent holes on landward shoulder and slope. (Fall 2018)

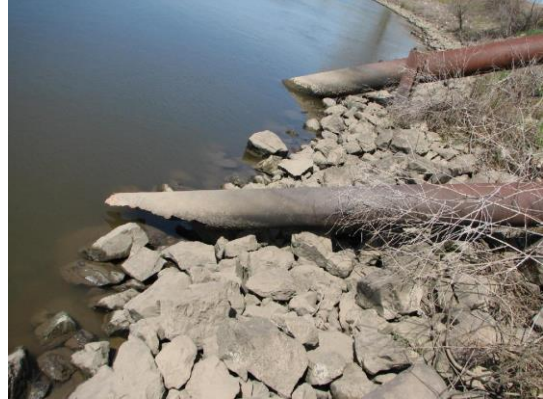
Photo 3 of 3 : UCIP_FA_2018_40672_72271.jpg

Pipe section inside wall has completely corroded--wall missing.

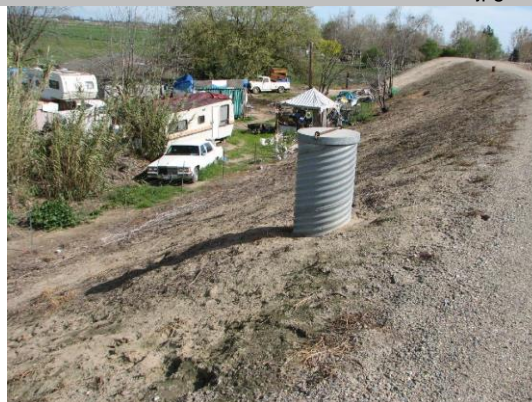
Photo 2 of 3 : UCIP_FA_2018_40679_72306.jpg

CMP riser located on landward slope.

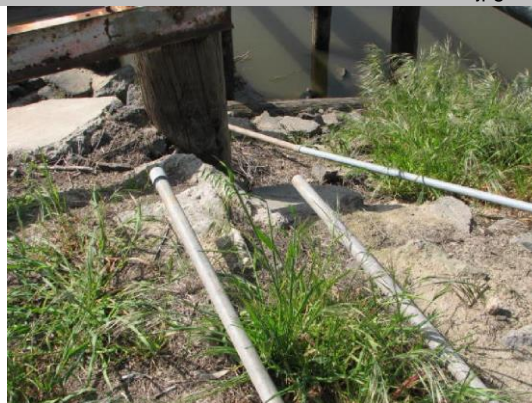
Photo 3 of 3 : UCIP_FA_2018_40687_72358.jpg

Conduit lines present on waterward side--no connection.

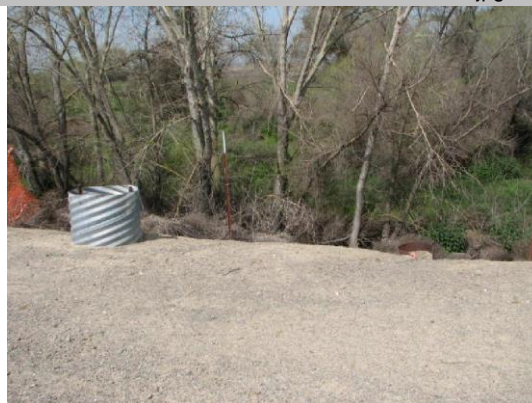
Photo 3 of 3 : UCIP_FA_2018_40689_72369.jpg

CMP riser located on landward side.

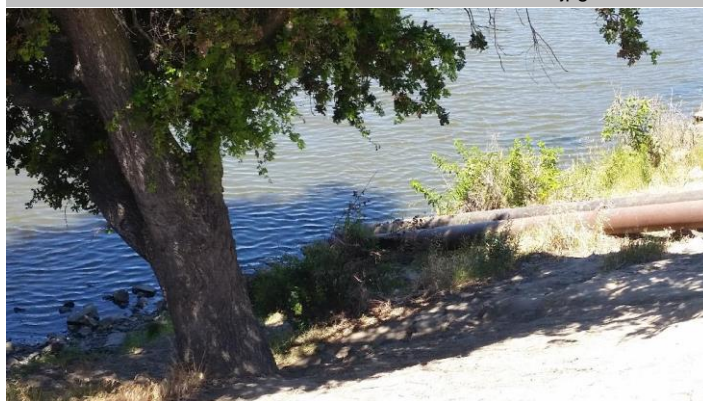
Photo 2 of 3 : UCIP_FA_2018_53331_75740.jpg

WS-pipe still damage, pipe wall section missing.

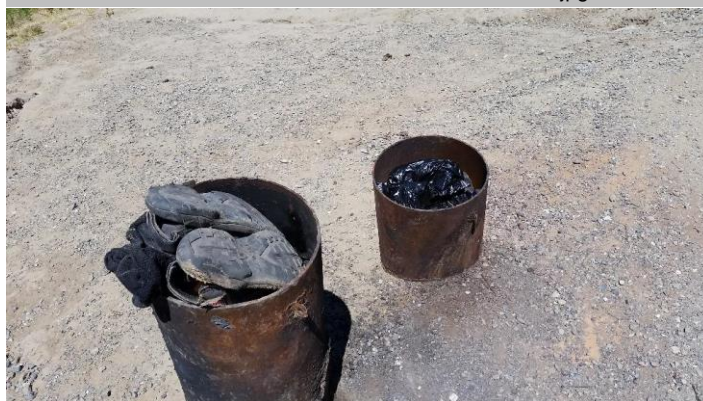
Photo 3 of 3 : UCIP_FA_2018_53331_75738.jpg

WS shoulder--protective housing units for siphon breakers.

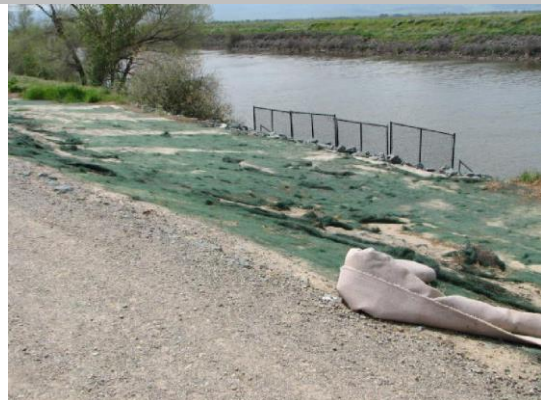
Photo 2 of 3 : UCIP_FA_2018_40696_72448.jpg

View of waterward side geotech fabric damage along slope.

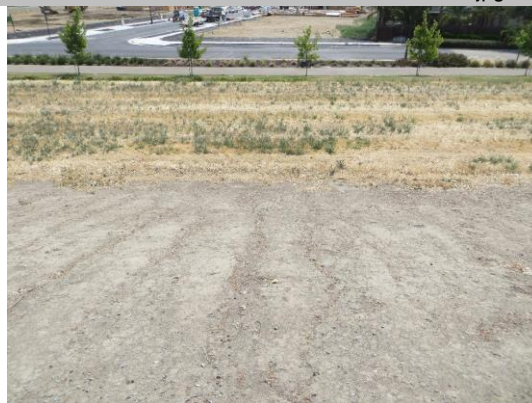
Photo 3 of 3 : UCIP_FA_2018_45463_74120.jpg

LS slope. No indication of pipe.

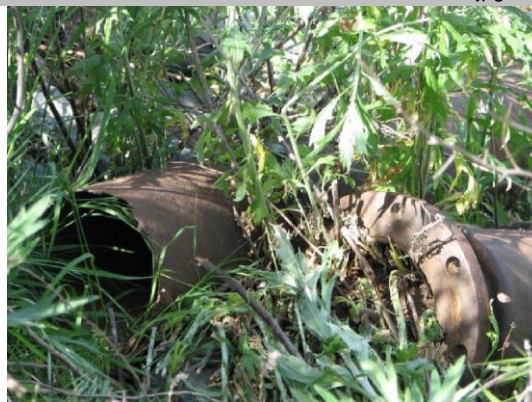
Photo 3 of 3 : UCIP_FA_2018_40706_72512.jpg

Non-functional crossing pipe disconnected.

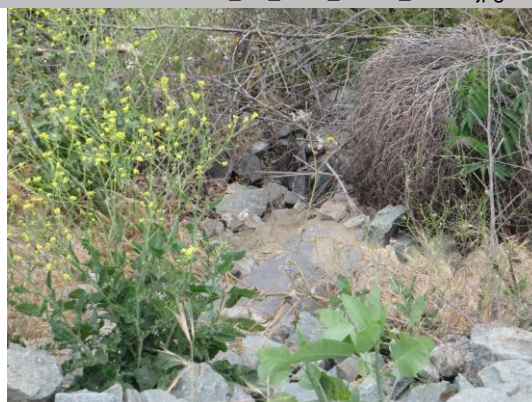
Photo 3 of 3 : UCIP_FA_2018_45466_74130.jpg

Pipe exposed in excavated area on WS slope.

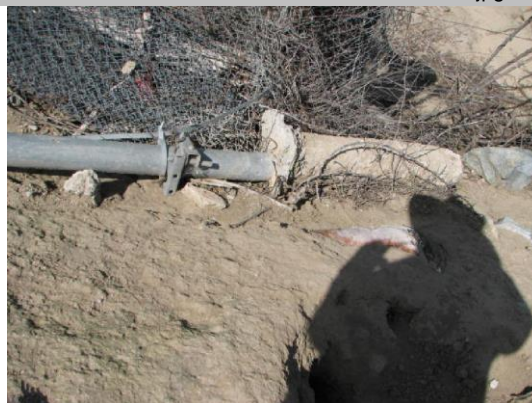
Photo 2 of 3 : UCIP_FA_2018_40712_72528.jpg

Pipe section exposed on landward side.

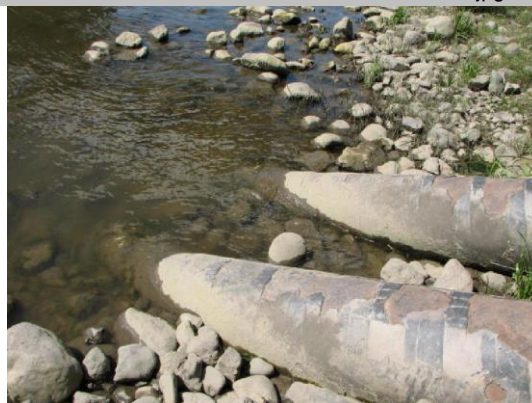
Photo 3 of 3 : UCIP_FA_2018_40713_72537.jpg

Sections of protective wrap missing near waterward toe.

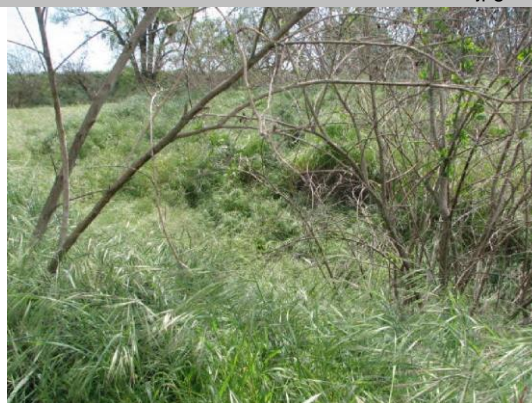
Photo 3 of 3 : UCIP_FA_2018_40716_72555.jpg

Scour hole located immediately upstream from crossing.
